# Manhole Inspection Summary

Manhole # S45G\_\_028MH

Insp Date: **7/15/08 8:49 AM**

**Location** Address: **1820 gough st**

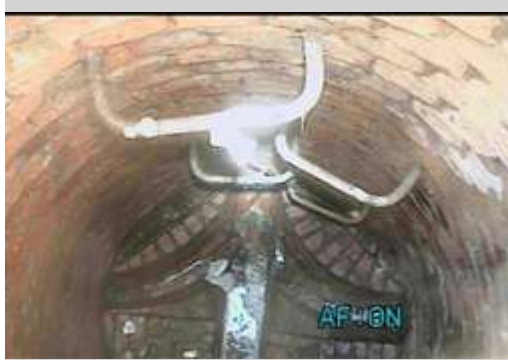
Defect 3

bench debris

channel debris

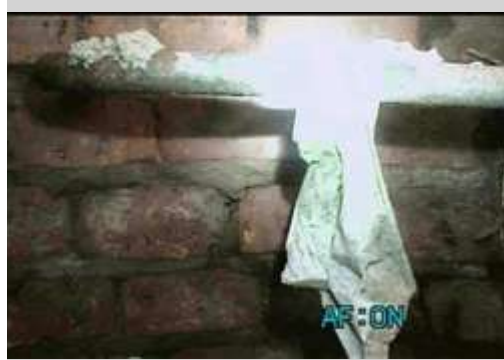
Defect 2

Count: **4** Missing: **0** ☒ **Corroded**

☒ **Evidence Of Surcharge**

Depth: **2.** (ft.) ☐ Active Surcharge Present

corroded Steps

evidence of surcharge

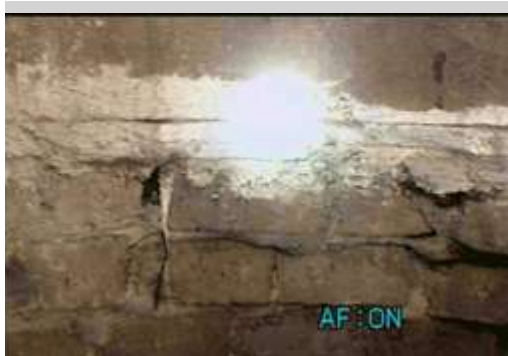
### Defect 1

Condition: ☐ Sound ☐ Cracked ☐ Root Intrusion ☒ **Loose Brick** ☐ Deteriorated

chimney loose bricks frame adj

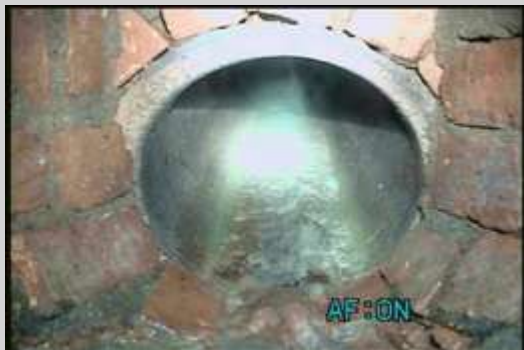
12 O'Clock Outflow

8 in. Circular Gravity Sewer  
Pipe Out @ 12 O'Clock

Invert Depth: **9.68** (ft.) Flow Characteristics: **Fast**

Deposits: ☒ None ☐ Mud ☐ Sludge ☐ Debris ☐ Grease

Infiltration: **None** Pipe Seal Cond: **Unknown**

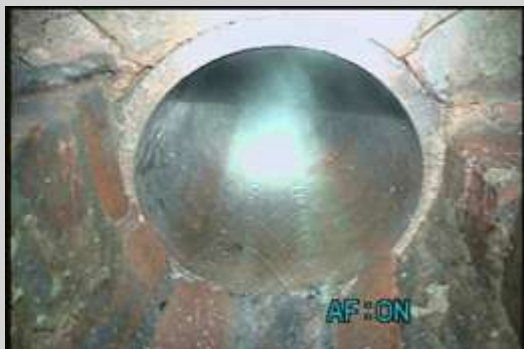
3 O'Clock Inflow

8 in. Circular Gravity Sewer  
Pipe In @ 3 O'Clock

Invert Depth: **9.61** (ft.) Flow Characteristics: **Fast**

Deposits: ☒ None ☐ Mud ☐ Sludge ☐ Debris ☐ Grease

Infiltration: **None** Pipe Seal Cond: **Unknown**

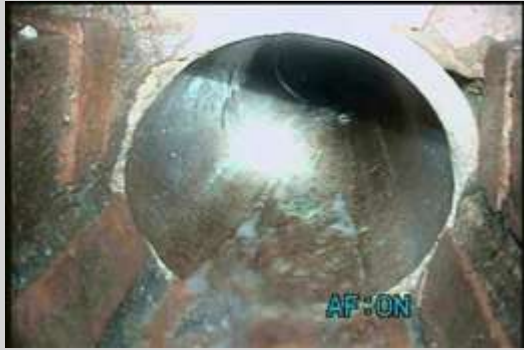
6 O'Clock Inflow

8 in. Circular Gravity Sewer

Pipe In @ 6 O'Clock

Invert Depth: **9.60** (ft.) Flow Characteristics: **Fast**

Deposits: ☒ None ☐ Mud ☐ Sludge ☐ Debris ☐ Grease

Infiltration: **None** Pipe Seal Cond: **Unknown**

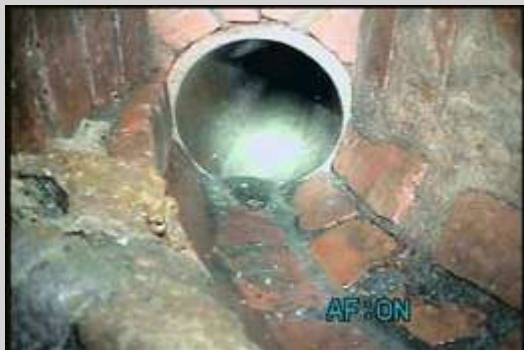
9 O'Clock Inflow

6 in. Circular Gravity Sewer

Pipe In @ 9 O'Clock

Invert Depth: **9.56** (ft.) Flow Characteristics: **None**

Connects To: **Dead End**
